## Engineering Geologic Report

Skyline Site Design  
Happy Camp, California  
APN: 016-412-240

JUNE 2015  
Project Number: 236

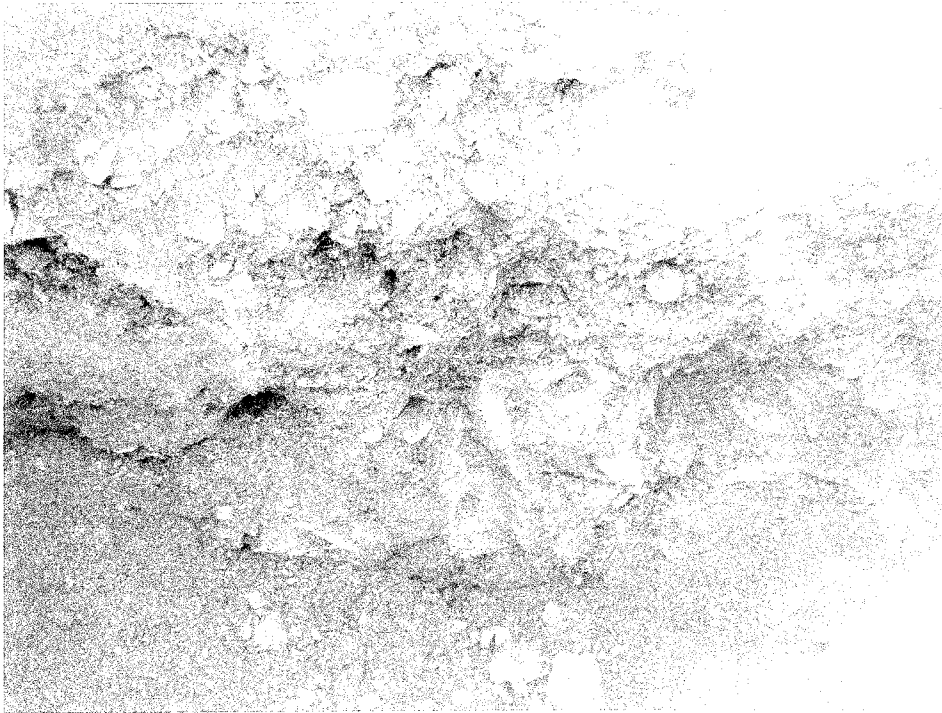
Depth (ft)	Material Description
3	Gravel-Sand Mixture (GP) – gray-brown coloration, low moisture content, dense to very dense consistency, contains gravels (subangular/angular) sourced from highly weathered and fractured metamorphic bedrock, well- drained, slight stratification, evidence of groundwater movement from oxidation of iron minerals (USDA classification: Loamy sand classification); Bedrock encountered at the bottom of pit @ 3’ – determined by resistance of backhoe and impedance of further excavation

Textural analysis of one sample (TP-1A) revealed a sand content of 78 percent, clay content of 6 percent, and silt content of 16 percent. The soil was determined to be a zone two material.

Photo #4: View of test pit #1

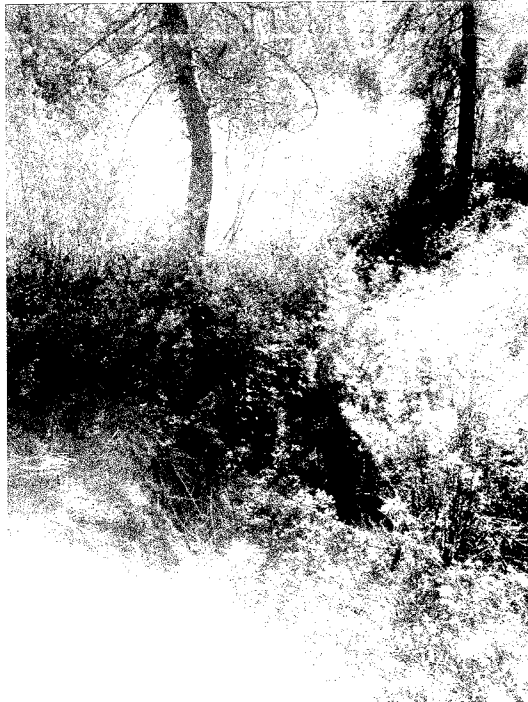
Photo #6: Excavated channels in bedrock along the southwest boundary

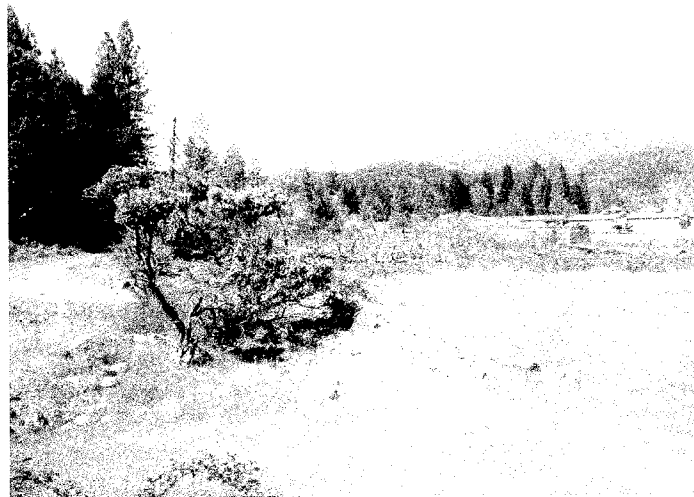
The parcel may contain undocumented fills associated with historic site clearing and grading. Due to the lack of nearly-flat, gentle slopes, and the proximity of bedrock to the ground surface at the project site, fills if they exist, do not appear to be a factor for this project, and their existing conditions appear stable. Any fills on-site have likely been in place for approximately 50 years and have likely experienced record setting rainfall seasons and relative strong motions from nearby earthquakes.

It should be noted that because of the lack of documentation of the placement and geotechnical criteria met for these fills, a definitive statement of stability cannot be made. Placement of any foundations on undocumented fills is strongly discouraged. No existing undocumented fill

Photo #8: Fill materials located on site

should be used as a structural fill to support building elements or their utilities without prior testing and approval of the project engineer.

If any existing undocumented fills are used: 1) to support structural building elements, 2) are within 3 feet of structural building elements, and 3) intended to support utilities of the building, these undocumented fill soils shall be tested in place to determine if they meet the appropriate compaction specifications listed below in section **4.1.3 Compaction Standards**, or removed.
